## Chamois Spotlight - Part 1 - from Graham Smith

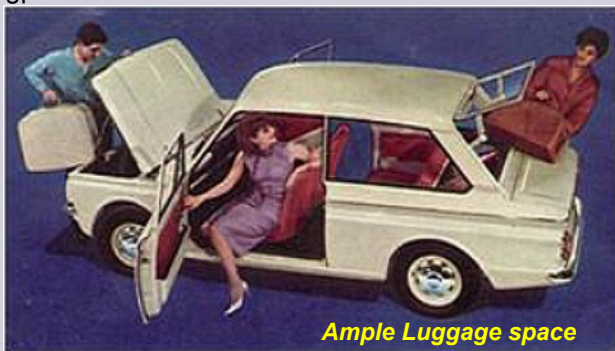
*Ample Luggage space*

The Imp was revolutionary in its design for a mass produced British car, having the engine installed in the rear, driving the rear wheels. The 875cc OHC aluminium engine was slanted at 45 degrees to give a lower centre of gravity and better space utilisation. The car also had an opening rear window giving access to luggage space behind the back seat, making it an early type of hatchback.
