Chamois Spotlight - Part 24 - from Graham Smith

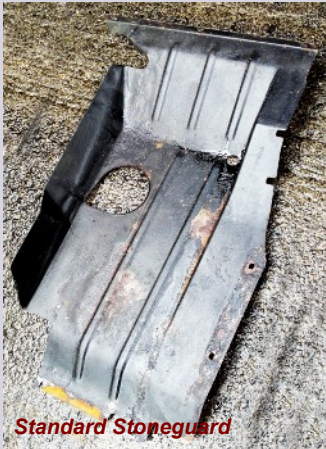
Standard Stoneguard

Inside the engine bay of the Singer Chamois there is a 'stoneguard', as the Haynes manual calls it, attached by screws to the car body above the exhaust silencer. The name implies that its purpose is to prevent stones and other debris being flicked up from the road by the right hand rear wheel and into the engine bay. In this Spotlight we discuss the pros and cons

of having the stoneguard in place, as it is often left off by owners of Chamois and Imps to allow better access for maintenance. We will examine whether it provides any other advantages or disadvantages for the well-being of the engine. The guard certainly provides a barrier to road debris entering the area to the right of the engine.

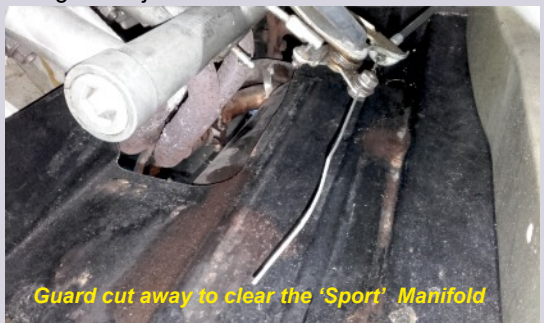
Guard cut away to clear the 'Sport' Manifold

The 1969 Chamois we acquired in March 2017 didn't have its stoneguard fitted, although it was included with the spare parts that came with the car. The previous owner had fitted a Sport exhaust and manifold, requiring modifications to the stoneguard which he hadn't got round to doing. As you may recall, we had fuel starvation problems initially with this car. I think I cured this fault by replacing the fuel filter, fuel pump, and blowing air through the fuel lines to clear any blockage. One of the other things I did just before we took the Chamois on last year's SNCR in Northumberland was to modify and fit the guard, involving cutting away a section of it to allow it to clear the four branch manifold. So far we have had no repeat fuel related problems of the first few weeks of having the car. How much benefit each remedial action made in sorting the problem is difficult to tell.
